## Meltshop Tackles Challenging Fall Protection Issue

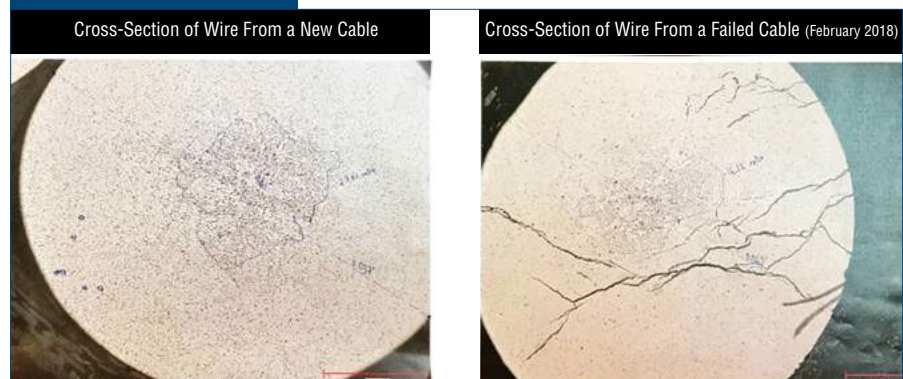
Figure 1

Prior to conducting work on the crane, the maintenance crew was performing a routine Competent Person inspection that included the horizontal lifelines used for fall protection on the meltshop charge cranes. During the inspection, a section of the lifeline was found to be deteriorated, as shown in Fig. 1. The damaged lifeline, which had been installed 5 years earlier, was replaced, and no other lifelines were found in the same condition. Approximately 16 months later, another horizontal lifeline in the meltshop began to show similar signs of damage.

During a visual inspection, broken wires were observed on the outer layer of the wire rope, and once removed from service, the lifeline laid broken in short pieces approximately 2 inches long.

View of damaged horizontal lifeline cable in place at the meltshop.

Furthermore, the removed cables, as well as brand-new cables, were pull tested to evaluate their strength. The 3-month-old removed cables from the meltshop failed at less than 50% of the unused cable. It was suspected that the root cause of the failure was that the outside layer had become brittle due to heat exposure during pour backs and dropping charges in the furnace.

Specifically for the bridge girders and end trucks, the existing guardrail was replaced with a specially designed fall protection system that serves as guardrail. This custom-designed guardrail includes a top rail that is designed for fall arrest, to take the place of the weakened horizontal lifeline system.

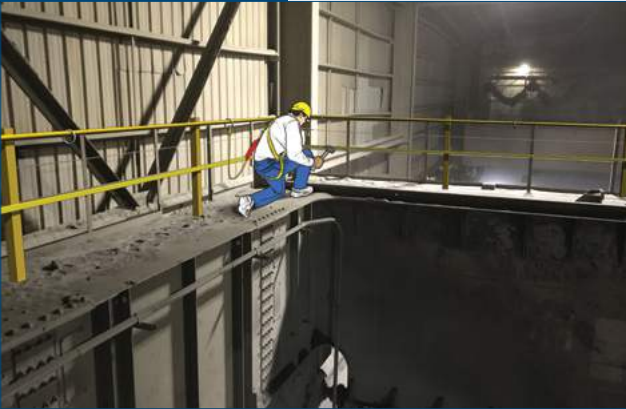
Figure 2

*Conceptual design of a fall protection solution for bridge crane and end trucks.*

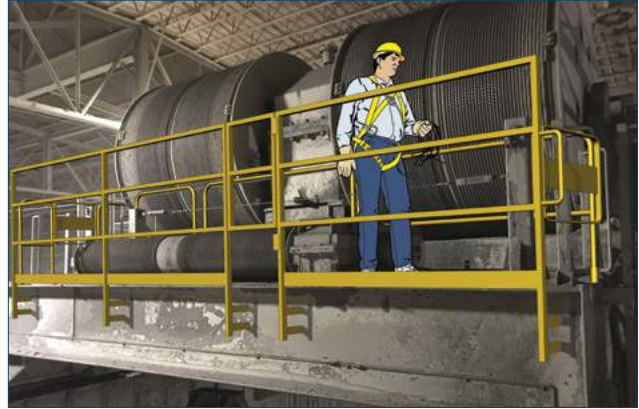
Figure 3

Conceptual fall protection solution for trolley maintenance.

For this meltshop fall hazard situation, the final solution included both engineering controls and active fall protection systems. For the trolley, the abatement solution is a raised guardrail with integral horizontal rail designed for fall arrest. LJB selected and designed the fall arrest rail with solid bar stock, replacing the horizontal lifeline systems that had been weakened by heat stress. On the outbound side, a lockable gate is provided in the raised guardrail for equipment removal. In this area, a fall arrest system is used for ladder climbing to gain access to the work location and protect against falls to the lower level (approximately 120 feet).
